## FACTORY DIRECTED MODIFICATION REPAIR AS DIRECTED

#### OIL LIGHT STAYS ON

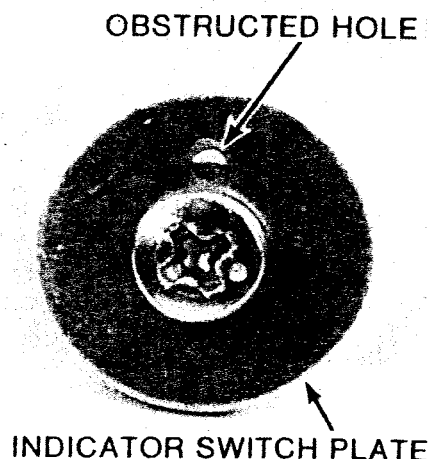
1. Remove the oil pressure indicator switch. Inspect the air-bleed hole in the switch plate.

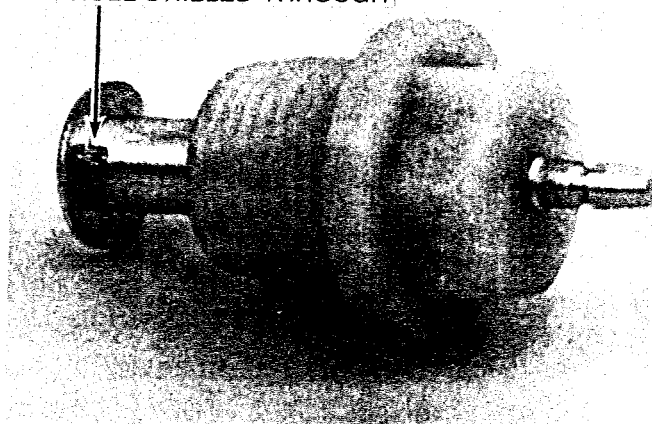
### HOLE DRILLED THROUGH

**Redrill the Air-Bleed Hole in the Oil Pressure Indicator Switch Plate.** The air-bleed hole may be partially obstructed by the end of the plunger. Redrilling it allows air trapped under the switch plate to escape.

2. If the hole is partially obstructed, redrill the hole 1.5mm in diameter (1/16 in. or No. 53 drill), as shown. **NOTE:** Do not exceed this diameter, or the warning light will not go out. Install the switch.

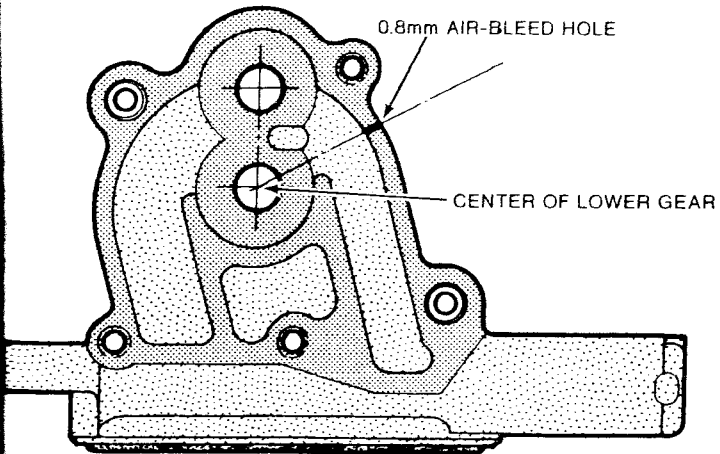
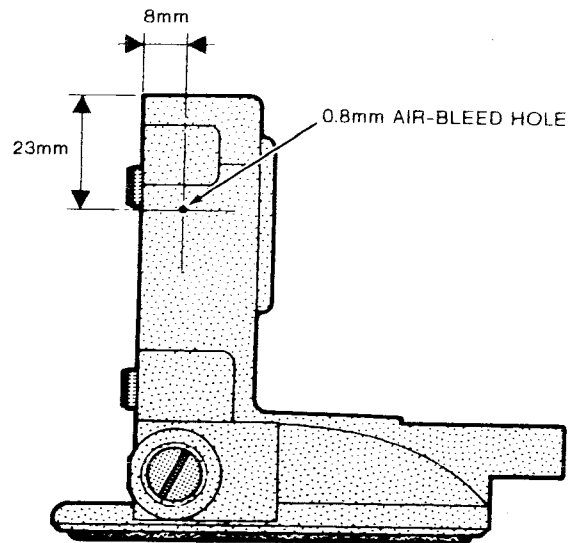
**Drill an Air-Bleed Hole in the Pump Body.** The air can escape through the air-bleed hole more easily than it can be pumped through the entire lubrication system.

6. To drill the pump air-bleed hole, first remove the gears and stuff rags into the oil passage holes. In the position and direction shown, drill a hole 0.8mm in diameter (1/32 in. or No. 68 drill). This hole should be spaced 8.0mm (0.32 in.) from the gasket surface.
