MOTORCYCLE INDUSTRY COUNCIL

## FACTORY DIRECTED MODIFICATION REPAIR AS DIRECTED

#### OIL LIGHT STAYS ON

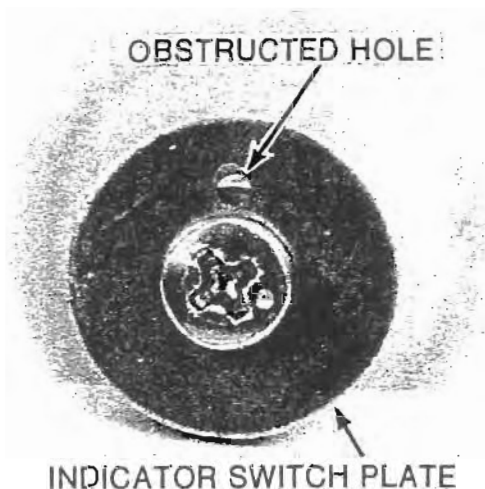
1. Remove the oil pressure indicator switch. Inspect the air-bleed hole in the switch plate.

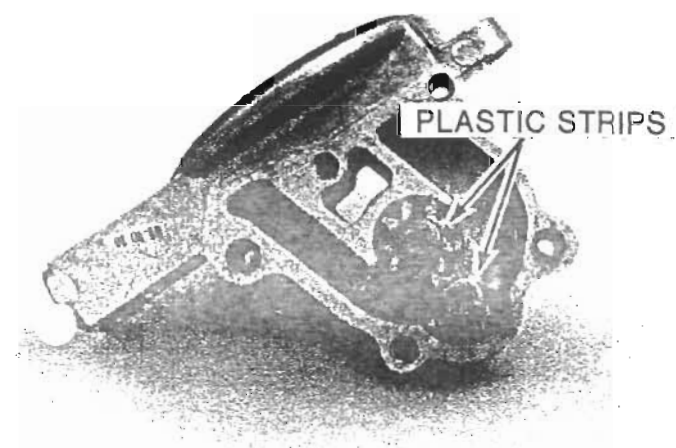
3. Remove the oil pan and the oil pump.
4. Measure the gear-to-cover clearance with Plastigage, as shown. Be sure to lay the plastic strip across the gear tooth with plenty of room for expansion. Consult the Clearance Table to choose the correct gasket and repair procedure.
