©Kawasaki Motors Corp. 1974 Printed in USA

PROBLEM:

On some Z1 models, the change pedal return spring contacts the crankcase when an upshift is attempted. Several different upshifting problems can result.

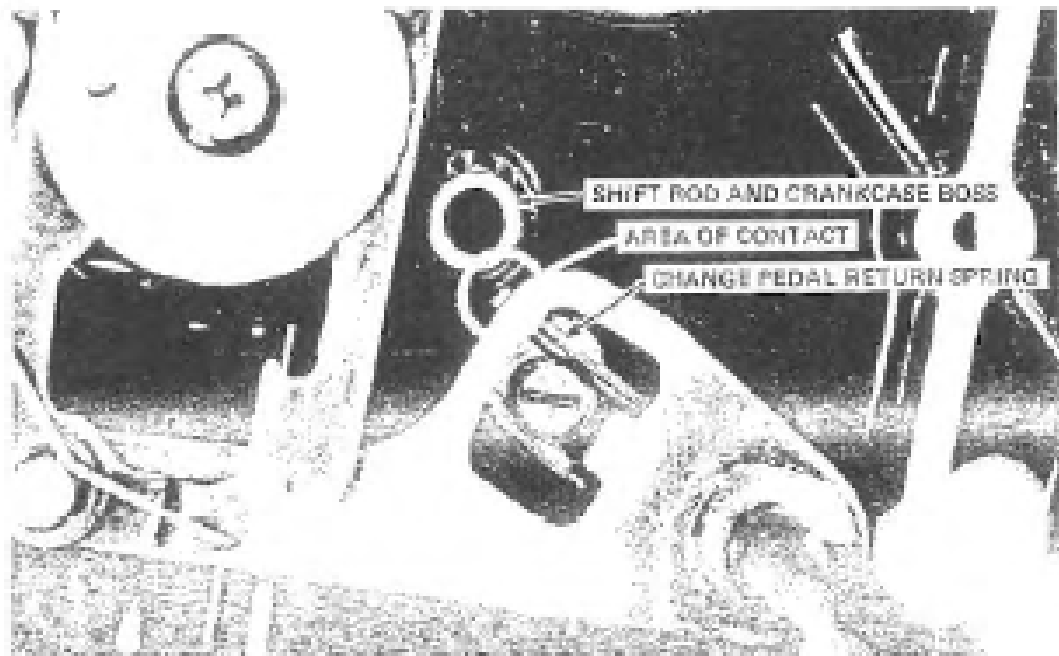
When the shift pedal is in the middle position, one end of the change pedal return spring is very close to the crankcase shift rod boss and moves even closer when an upshift is attempted. The spring contacts the boss and produces any of the aforementioned problems.

To prevent the change pedal return spring from striking the crankcase, the manufacturing tolerances of the spring length have been changed. This new spring is used in Z1 production beginning with engine Number Z1E-D4821. To correct upshifting problems that are caused by an old style return spring, either a new style return spring can be used as a replacement or the old style spring can be modified by removing 1-2mm from the ends.
