# Mission impossible

This month Rod's mission, should he choose to accept it, is to put together a good Z250 engine from two abused donors – after they both tried to self destruct within five seconds.

# Mission accomplished

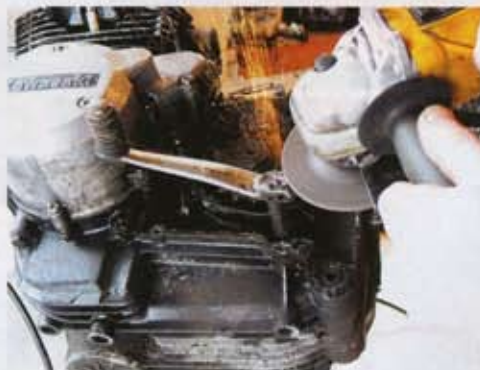
1: Jonathan had helpfully labelled the engines up for me, so one bore the legend 'clutch gone, good engine', and the other 'engine gone, good clutch'. After a bit of chin scratching, it seemed best to strip and rebuild the good engine, robbing bits to fix the clutch problem from the other one. To begin with, the gearchange lever had been welded onto the shaft, presumably as the splines must be worn out. No problem, there's a good spare shaft on the other motor, so it's out with the angle grinder to cut the gear lever off.

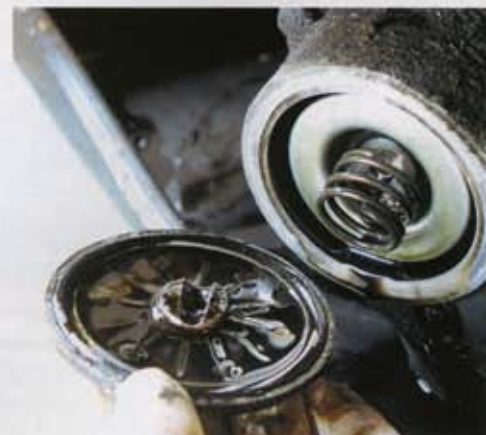
2: Oh dear, this stripdown is going pear shaped already. A good heave on the oil filter cover succeeds in shearing off the hollow aluminium bolt. Of course this bolt is usually a steel insert – it seems Kawasaki's designers opted to sacrifice durability in favour of saving the weight of a postage stamp here. Not to worry, there's a good housing on the spare engine, but a sense of foreboding begins to develop.

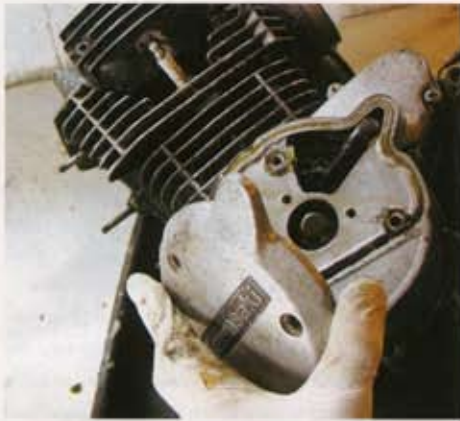
3: The generator cover has a separate outer cover, retained by three mashed up countersink screws. A little persuading from the impact driver and the screws thankfully come free, revealing the bolt on the end off the crank and the alternator wiring. It's a rather over elaborate design, but I'm sure there must have been a good reason for it.

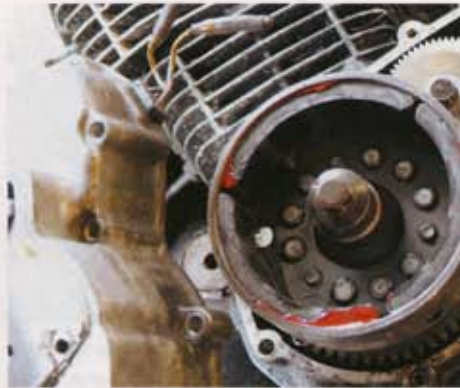
4: The generator cover comes off next to reveal a period Kawasaki nightmare. There should be red epoxy around the edge of all three magnets, but it's broken up and disintegrated. And guess where most of it's gone – into the sump and round the engine. It didn't affect only the Z250s, some Z1000Js and Z1100s suffered from the same thing too, and caused all kinds of warranty nightmares for dealers and owners at the time.

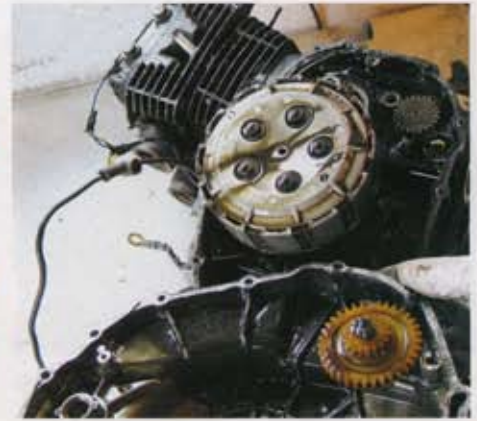
5: Round the other side, the engine cover comes off easily, revealing a sludgy but basically healthy looking primary drive and clutch. Note the nylon gear for the tacho drive and oil pump – a potentially rather flimsy design option, but I've never heard of one failing in service. No sign of any clutch problems so far, so I'll proceed and strip it a bit further.

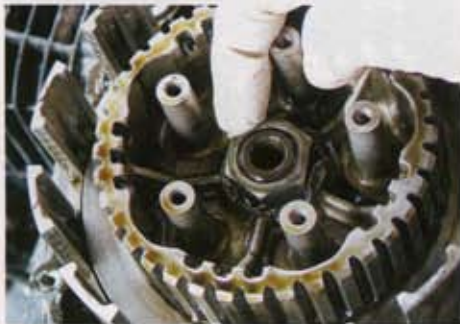
6: The clutch has obviously been apart in the past as the centre nut is loose, it's only the half bent over locktab that has stopped it falling off. It's another discouraging sign of a badly abused bike, but it's not enough to have stopped the clutch working. In fact, the clutch problem is a bit elusive, all the plates are present and appear serviceable and in theory I fail to see why this clutch was presenting any problems.

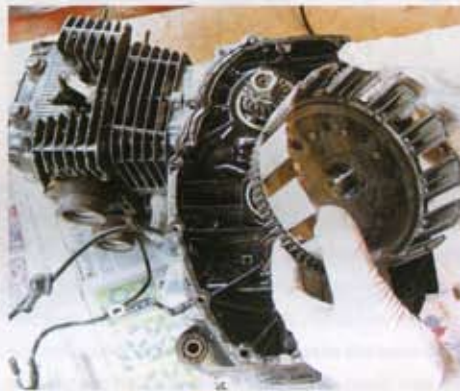
7: Here's the clutch basket as I lift it away from the end of the input shaft. Note the primary drive gear on the end of the crank, also retained by a dodgy looking old locktab. This part of the design follows conventional practice, and I can't see any reason why it was giving problems.

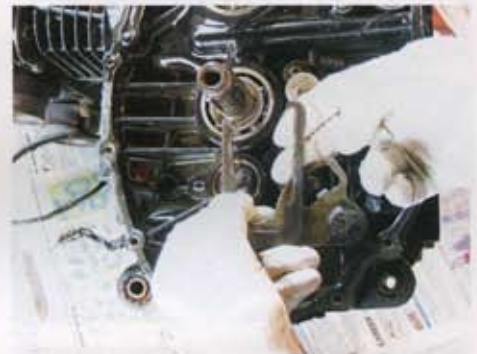
8: Behind the clutch lies the gear selector mechanism. Unhooking this twin claw from the end of the selector drum allows me to pull the gearchange shaft out of the engine and discard it – this is the bit with the dodgy splines I had to grind off at step one. I'll have to strip the spare engine at least this far to rob it of its (healthier) gearchange shaft.

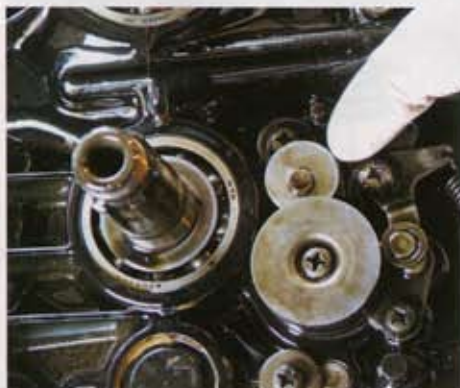
9: This little device serves to click the gears into place. It's a spring-loaded detent arm, and the roller I'm pointing at clicks into position between a number of pins on the end of the selector drum. You can see how badly worn the roller is – it's well offset from its pivot pin and is clearly a candidate for replacement. But again, it shouldn't have been causing noticeable problems in service.

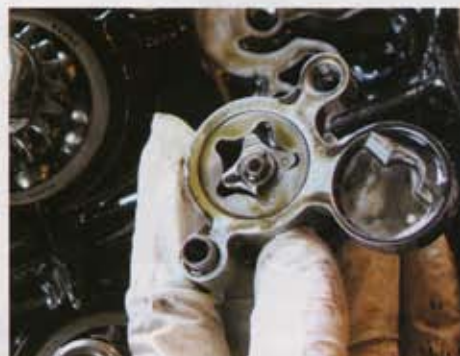
10: Oh dear, oh dear, oh dear. This tiny little thing is the oil pump – an unbelievably small and fragile looking device. Not only is it tiny, it's badly scored. The grooves around the faces of both rotors have almost certainly been caused by bits of swarf or detritus getting drawn through it – guess where all the epoxy fragments from the generator rotor went. More worryingly, the oil pump bears against the crankcase face – if that's scored too we're in trouble.

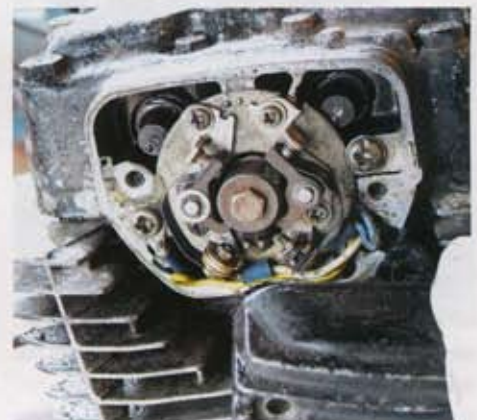
11: With the bottom end more or less stripped at both sides I'd better have a look at the top end. Removing the points cover reveals the mechanical contact breaker set-up. Note the bodged wiring and damaged insulation just visible on the blue wire to the right of the picture. This was almost certainly shorting out against the points cover. Was it misfiring, Sir?

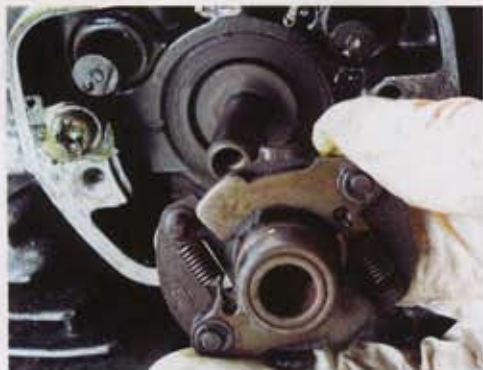
12: Behind the points plate is the auto advance unit, driven at half crank speed on the end of the camshaft. This, at least, looks to be in serviceable condition. There's an oil seal behind the unit, sandwiched between the head and the cam cover, which will be replaced on the rebuild.

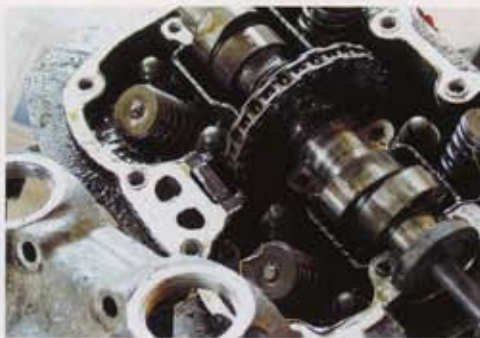
13: The cam cover lifts free once all the bolts have been removed, revealing the camshaft and its drive chain. The rockers are captive on the underside of the cam cover – I'll take a look at them later – but the cam lobes on the right-hand side look a bit battered. Note the top of the rear tensioner blade behind the camchain, and the eight domed nuts that retain the cylinder head.

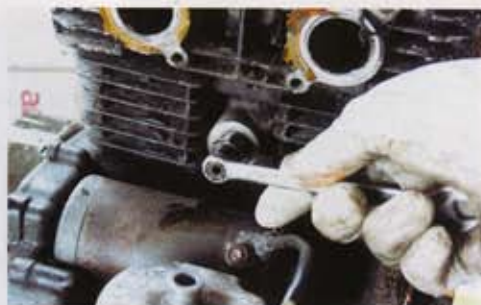
14: Before I can remove the camshaft I need to slacken off the chain. The camchain tensioner lives behind the cylinder barrel, and is a pretty substantial device – rather reminiscent in fact, of the Yamaha design fitted to the XS650. Unlike Kawasaki's bigger 400 and 750 twins the Z250/305 uses gear primary drive instead of chain, meaning the crankshaft rotates 'forwards' and the tensioner is at the back of the barrels, not the front.

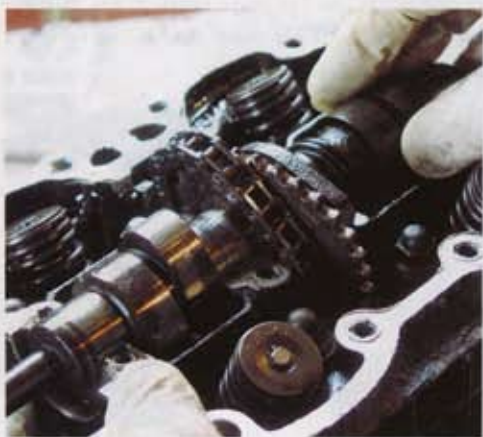
15: Now the camchain is slack I can remove the two M6 bolts that hold the camchain sprocket to the camshaft and drop it down, off its mounting, onto the side of the cam journal.

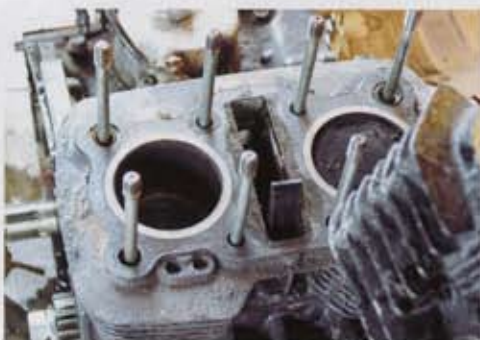
16: With the camshaft out of the way I can slacken and remove the eight cylinder head nuts, working in a diagonal sequence, then lift away the head. Now the front camchain slipper blade is revealed. The oil feed for the cam bearings travels upwards through the two rear outer stud holes – note the O-rings fitted into the gasket to prevent leaks.

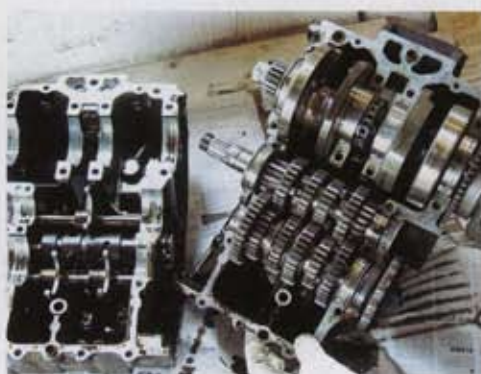
17: In theory the barrels should now pull away from the crankcase mouth, but these aren't going to shift without a struggle. It's sometimes possible to help them budge by gently tapping the cylinder liners upwards from inside, so I'm taking the unusual course of splitting the crankcases with the barrels still in place.

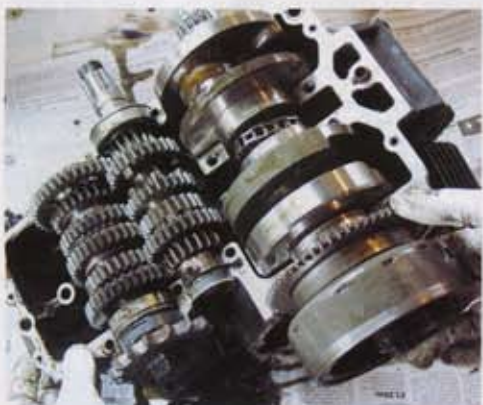
18: Note the camchain sitting loosely on the crank sprocket. Behind the crank is the input shaft, and behind that the output shaft. Six cogs on each shaft confirm this is a six-speed box.

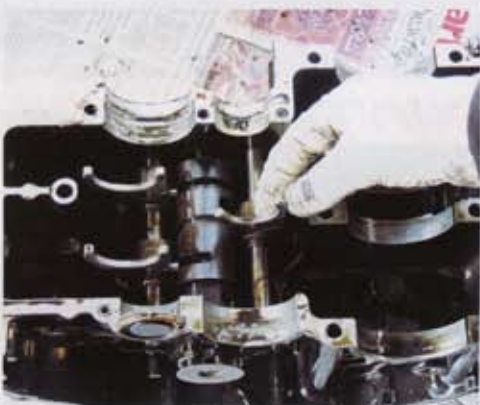
19: The lower crankcase half carries the gear selector drum and forks. These are now simple to remove, but I'm always careful to mark which location the selector forks have come from.

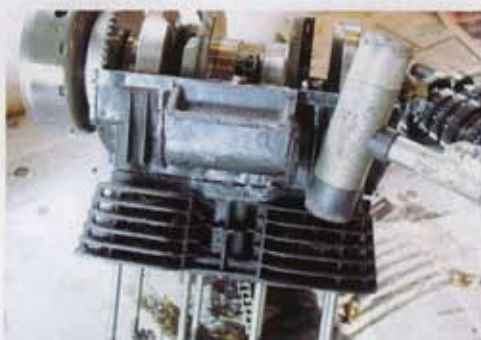
20: I've been lucky here. A bit of gentle persuasion has shifted the barrels off the crankcase mouth and I can proceed to tap them down the studs with a rubber mallet to release the pistons from the bores. It's easy to damage a fin this way so carefully choose where you apply force.

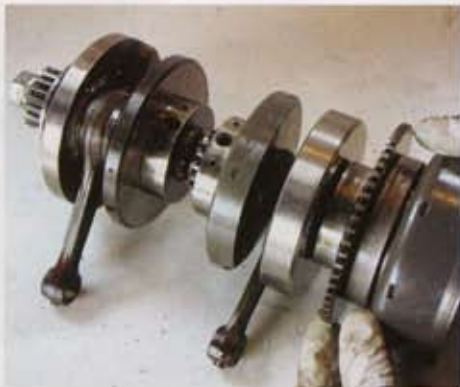
21: Here's the crank assembly. We used to supply lots of Z250 cranks for warranty claims, so many that they were on shortage at Kawasaki Europe for a long while. Most of the problems seemed to be caused by inadequate lubrication, for as a pressed-up roller bearing design the crank assembly should be a tough little unit. This one shows no obvious signs of distress, and gets a provisional 'thumbs-up' as reuseable.

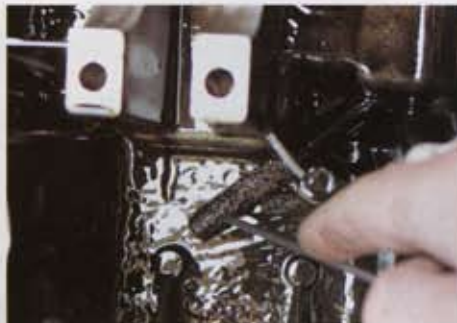
22: Now back to cloud-cuckoo land at Kawasaki's design office. This sump strainer gauze lives behind the oil pump in the lower crankcase and should be cleaned at each service. But as you have to remove the oil pump to get at it, most owners don't know it's there. This one is almost completely clogged with crud, including remnants of the epoxy from the generator rotor. And check out the thick sludge in the crankcase bottom – the Z250 has no removable sump so it's a crankcase split to clean that lot out. An awful bit of design work.

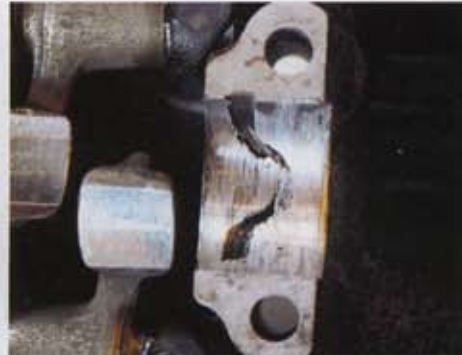
23: And here's one of the results of the clogged-up oil feed. This cam bearing in the cylinder head has been starved of oil and is completely goosed. The matching journal on the camshaft has suffered too, so right now it's looking like the spare engine may be donating its head and cam for the rebuild – if they're any better. This kind of damage can be repaired, but it's a tricky and expensive process – let's hope we don't have to.

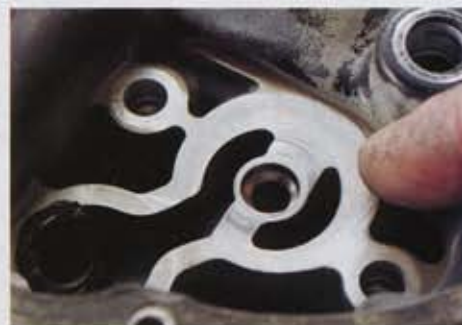
25: Finally, the verdict on the crankcases. This is the working face for the oil pump and, as you can see, it's pretty badly scored. Getting the surface machined flat is quite a specialised job. Even fitting a new oil pump to this face is unlikely to restore oil pressure to a good working spec, so it looks like I'll be stripping the spare engine to see if that one is better. A decision to change crankcases also means the engine number will no longer match the frame, which needs to be discussed with the owner before I proceed.

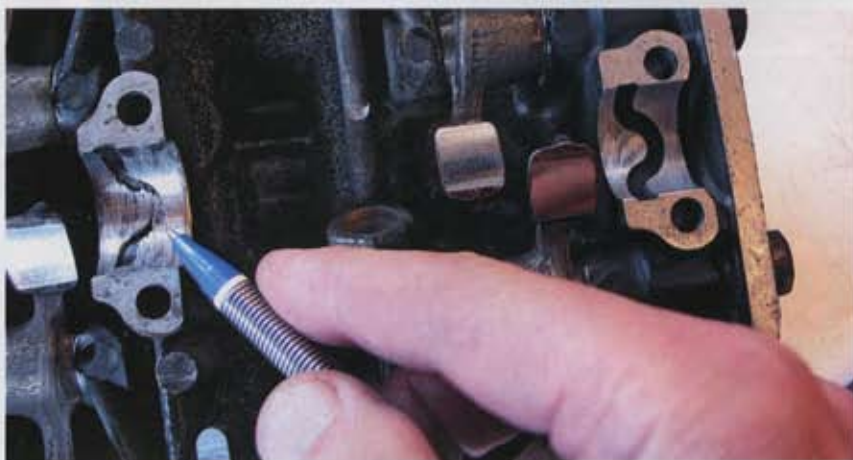
1: A quick recap of the first engine to begin with. All the cam bearings are scored, but this one is thoroughly mashed up. The cam followers seem to have escaped serious damage, surprisingly. This is the underside of the cambox; cam bearings are machined as a set so it's essential to never mix and match camboxes and cylinder heads – the pair must always be used together or the bearing clearances could be incorrect and lead to rapid wear or more seizures. For the same reason, be wary of buying cylinder heads for DOHC fours without cam caps – they are part of the head assembly and should never be mixed.

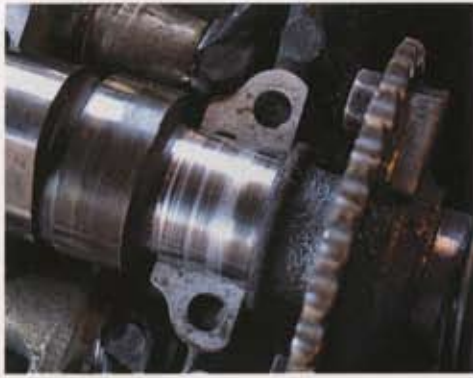
2: Here's the matching damage to the camshaft journal. Now it's degreased you can see the scoring on the bearing surface. This kind of damage can be repaired by machining the journal back to round, but as it will then be undersize the corresponding head bearings will have to have new bearing shells made up to match – more on this later. What's caused the damage? Usually skipped oil changes are responsible, but on this engine we know that epoxy fragments from the generator have been pumped round with the oil, so it would be unfair to blame the owner.

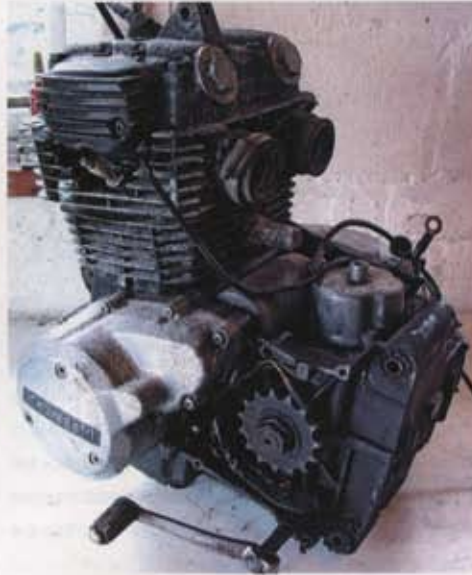
3: Right, let's get stuck into the second engine. This one is marked 'bad engine, good clutch'. Apparently it simply died at the roadside one night and has refused to run ever since.

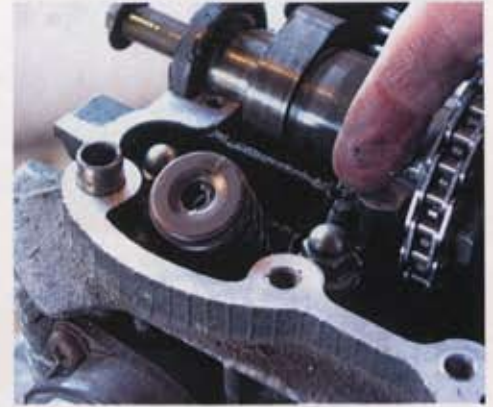
4: Whipping off the cam cover immediately gives a clue to the problem. The left-hand inlet valve top collar has come adrift, and there's only one spilled cotter showing. Peer closely below my fingertip and you'll see the valve clearance adjuster screw, which of course should be captive in the rocker arm. There's one cotter and one locknut to be accounted for, but clearly the inlet valve wasn't opening as it should. With a bit of luck this engine could be salvageable.

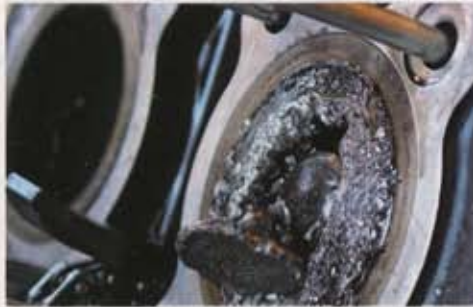
5: But, alas, Lady Luck is looking the other way. Yes, that's what's left of the piston crown and valves from the left-hand cylinder. Oops, as we say in the trade. It looks like what's happened is the valve clearance adjuster has come loose and fallen out, pausing briefly to wedge itself between the rocker arm and the top of the valve stem on the way. The inlet valve has collided with the exhaust valve and the whole lot has thwacked into the piston crown, writing off the lot.

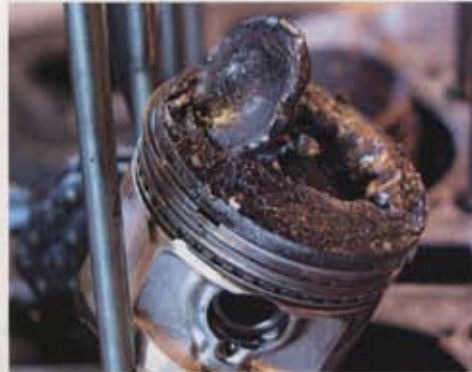
6: Pulling off the barrels reveals a sarcastically servicable bore, but the rod has suffered quite an impact, so a crank rebuild would have to be on the list to even consider saving this engine. Plus there's a bucketload of alloy swarf, which has gone round the engine, clogging up oilways and scoring moving parts. "Beyond economic repair" is what we'd be writing on the jobsheet.

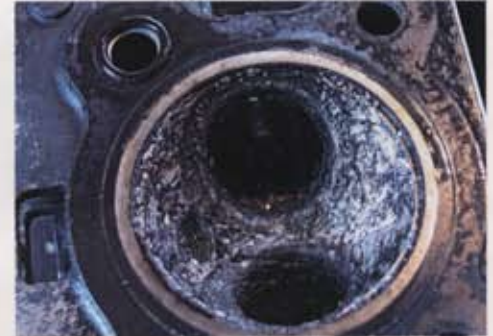
7: The final irony is that the cam bearings were in good condition in the head, but the head has been written off by all the bits of metal rattling around in the combustion chamber. Ah, well. The cause of all this mechanical carnage is probably down to someone failing to tighten a locknut on the valve adjuster correctly. People frequently overtighten them, but this time it's a lack of spanning that's caused the problem.

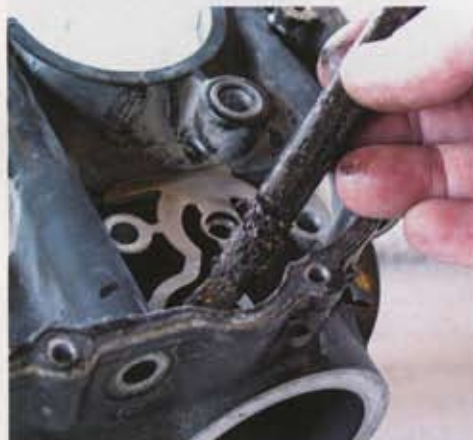
8: Fast forward now, as I need to know if I can use the crankcases. I've followed the same procedure as last month to strip the engine and split the crankcases. I've removed the tiny oil pump from the crankcase and I've managed to retrieve what's left of the crank strainer gauge. And, yes, the crankcase was full of sludge and metal swarf.

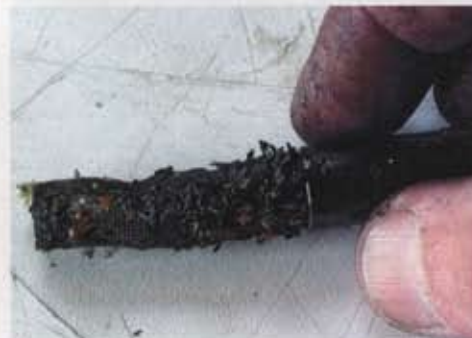
9: Just like the strainer on the first engine, this one is almost completely clogged with detritus. In this case, of course, there's been a lot of swarf driven around the engine, but not all of it is fresh. And there are bits of epoxy from the rotor there, too, in its telltale orange colour. If you own a Z250 or 305 put down the magazine right now, go out to the garage, take out your sump strainer gauge and give it good clean before disaster strikes you too.

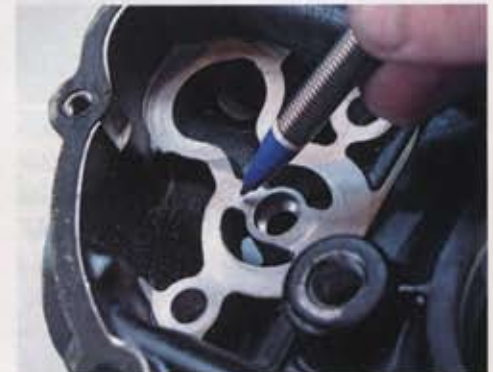
10: The good news (and there had to be some eventually), is that the oil pump mounting face on this engine is in much better condition than the first one. It's not perfect, but without resorting to spending serious money it's the best we're going to get. The oil pump rotors are pretty good too, so at least by swapping crankcases I've managed to salvage a useable lubrication system.

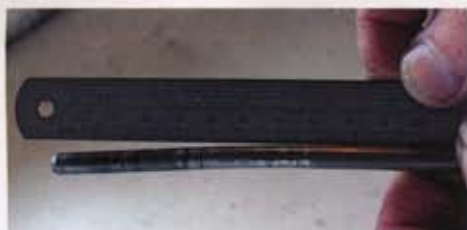
11: Before moving on, the mystery of the 'bad clutch' is finally solved. Having degreased and washed all the engine parts, it was while sorting through them for the best bits that I came across this bent clutch pushrod. It may have been bent by a broken drive chain parting company with the engine, but whatever caused it, it could have been fixed by simply fitting a new pushrod without any need for stripping the engine from the bike. Not to worry, at least we've discovered the other problems that needed fixing.

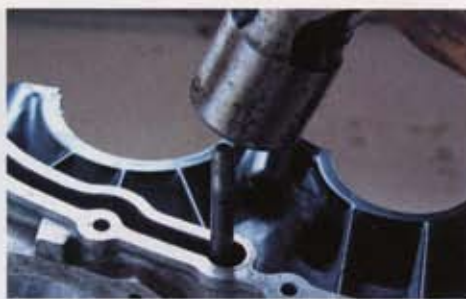
12: Now for a bit of left field engineering. I'd been tipped off by Bob Hunter of TA Bikes in Maldon that the main oil supply gallery on the Z250 is sometimes partially obscured by the alloy blanking plug pressed in to the timing side of the crankcase. The answer is to tap it out and modify it. The bent clutch pushrod inserted from the clutch side makes a perfect drift to tap the blanking plug out from the other end.

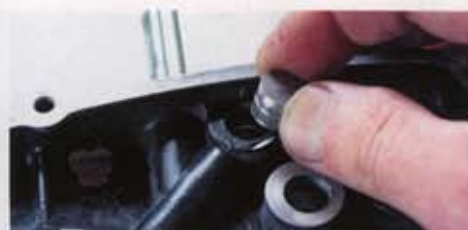
13: Here's the blanking plug as it emerges from the crankcase. The main oil feed travels through a gallery diagonally downward to the main bearing - you can see the ridge in the crankcase which marks its passage. The blanking plug is frequently long enough to partially block this oilway, restricting oil flow to the crank and leading to bottom end failure. This was a bad habit at Kawasaki; lots of the Z250 singles suffered from camshaft oil ways restricted in a similar way by overlong tachometer drive gears.

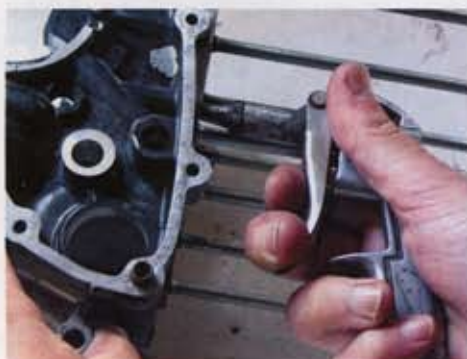
14: This crankcase has had swarf in it, so with the blanking plug removed I've degreased and washed it all again, then blown compressed air through all the oilways to make sure everything is clear. This is always important on any engine, but vital when metal swarf is known to have been present.

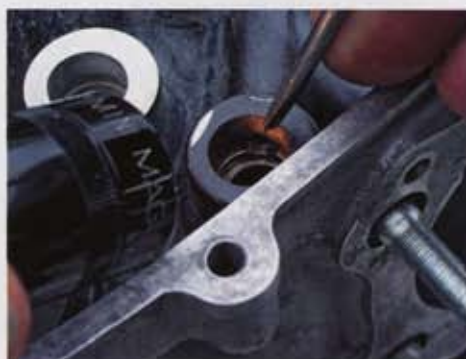
15: Having talked about the oilways I'm determined to get a good picture of them, but it's not easy. Just visible in the light from my torch is the end of the oil feed gallery for the timing side main bearing. Measuring down from the crankcase, it's about 8mm inboard where it connects to the main gallery.

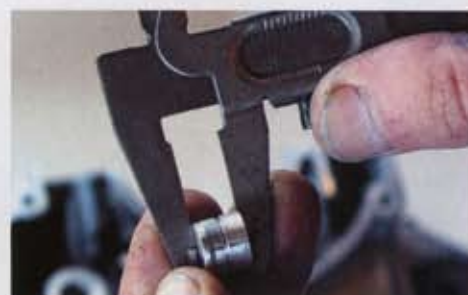
16: Now take a look at the blanking plug. That's right, it measures 10mm long. When pressed all the way into its housing, therefore, it's half obscuring the oil feed to the main bearing. It's a ridiculous error for Kawasaki to have made, and if I hadn't seen examples of their equally ill thought out camshaft/tachometer drive gear problems on the 250 singles I wouldn't have thought it possible. So that's why these engines eat cranks...

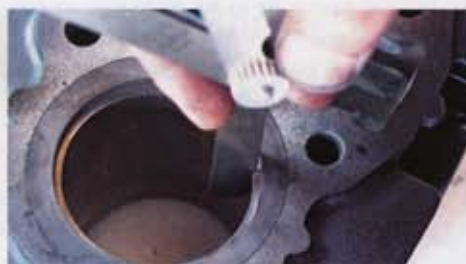
18: Now I can begin to sort out the best bits from both engines and gather it all together to assemble one good one. The barrels and pistons from engine number one are in serviceable condition, more or less, with a ring gap just within manufacturer's tolerances. Ideally I'd like to bore it, but the budget has already far exceeded the value of the bike, and producing an engine that is merely serviceable (instead of blueprint perfect) now has to be my goal.

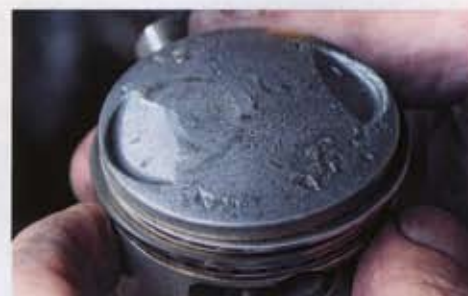
19: This is the right-hand piston from the damaged engine, which I won't be reusing. It looks pretty battered too, and you can see the mark where the inlet valve has hit the piston crown. If we were really desperate it could be pressed into service again, but I'm relieved to have two more pistons that are in much better nick, and they match their original bores.

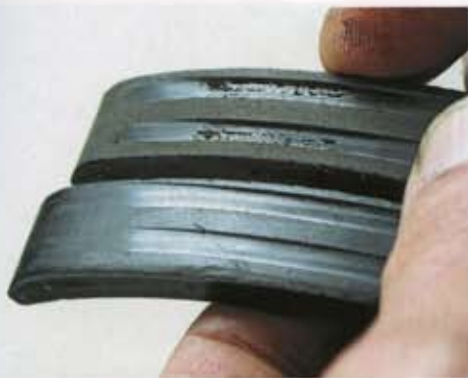
20: There's wear, and there's wear. Both of these camchain slipper blades have seen better days, but while the lower example is merely worn the upper one is beginning to break up as the rubber has hardened in use. Tiny fragments of rubber from this blade would contaminate the oil. Remember the crud blocking the crankcase strainer gauze? Here's one source of it all. In the bin with it!

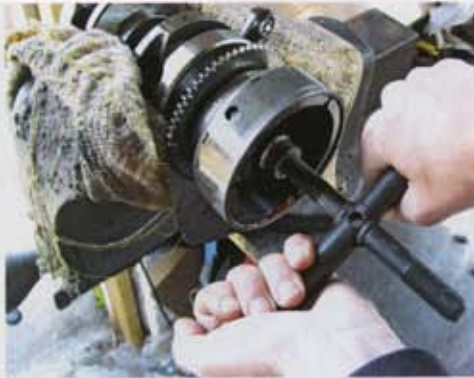
21: One thing I haven't looked at yet is the starter clutch assembly, mounted on the back of the generator rotor. It's a tight fit on a taper, so rather than chase the engine round the workbench trying to tap it free I've left it until now. Padded with rags it's an easy job to clamp the crankshaft into the vice and use this rotor puller (a genuine Honda service tool, incidentally!) to free the rotor from its taper.

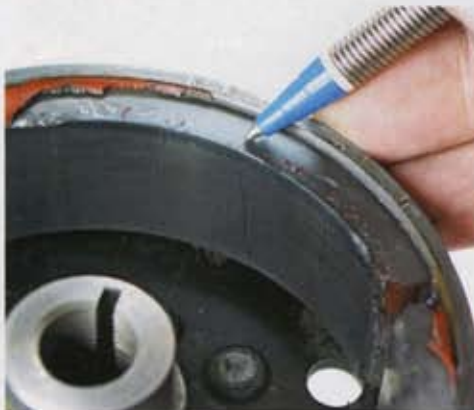
22: I've two generator rotors to choose from and both have flaky epoxy insulation, but close examination reveals a crack in one of the magnets. I've lost track of which engine this one came from, but the other is crack free, so this one is scrap metal. The consequences of the magnet fracturing at high rpm are not good. It's one more disaster waiting to happen.

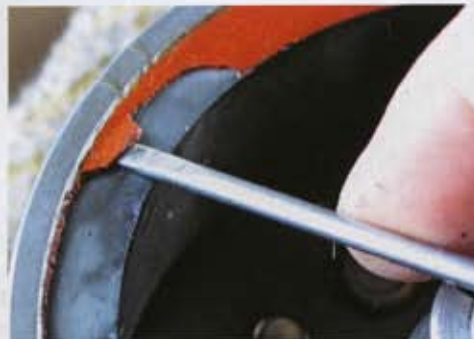
23: This was another Kawasaki problem of the period and it afflicted their big fours as well as the little twins. This epoxy coating breaks up in service, flakes off and drops into the oil, where it gets driven round the engine in tiny abrasive particles doing untold damage to bearing surfaces and oilways. Replacement rotors simply do it again, so the answer is to painstakingly chip all the remaining epoxy off the rotor with a hammer and small screwdriver. It seems to do no harm running without it.

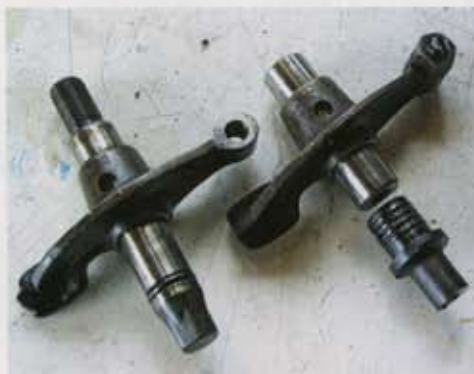
24: I've merrily set about choosing the best four cam followers and got as far as assembling them into the cambox before I realised Kawasaki changed the design part way through the production run. The screw in cam follower spindles (left) were superseded by shorter, one piece items with rubber bungs (right). The rocker arms remained unchanged, so I can still use the best four, but the spindles must match the cambox, which, in turn, must match the head.

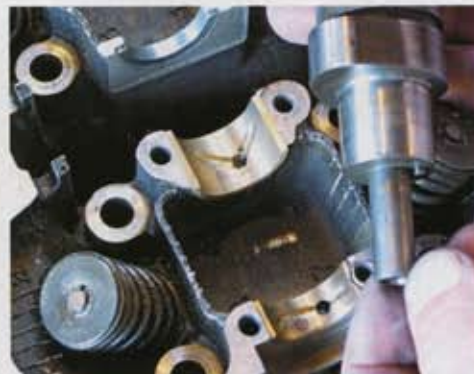
25: While all this lot has been proceeding, my old pal Jim at JME Engineering has done the business with the cylinder head and camshaft. The cam journals have been machined back to round and new phosphor bronze shell type bearings have been made up to suit. The original bearing surfaces in the head have been opened up to accept the shells, which are then pinned in place and drilled to meet the oilways. It's not an easy (or cheap) procedure, but it's saved the head and ultimately the engine.

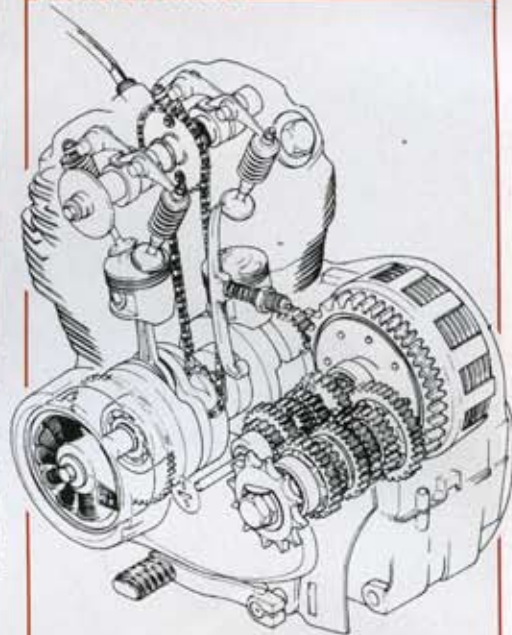
## ENGINE CUTAWAY

Reduced to a line drawing the Z250 engine looks pretty simple. The four-stroke parallel twin is air-cooled and has its cylinders firing at 180 degrees, so one piston is at the top of its stroke while the other is at the bottom. The single overhead camshaft is driven by a single row camchain running upwards between the cylinders, tensioned by a spring loaded plunger acting on a slipper blade at the rear. Rocker arms translate the movement of the cams to open and close the valves; one inlet and one exhaust for each cylinder. The crank drives the clutch by a set of straight-cut primary gears. The clutch is bolted to the right end of the gearbox input shaft, which in turn drives the output shaft through six gear pairs (for six speeds). The drive sprocket is mounted on the left-hand end of the output shaft. The clutch is actuated by a pushrod running through the hollow input shaft, with a lifter mechanism just forward of the engine sprocket (not shown). The generator is mounted on the left-hand end of the crank, with the starter clutch bolted behind it.

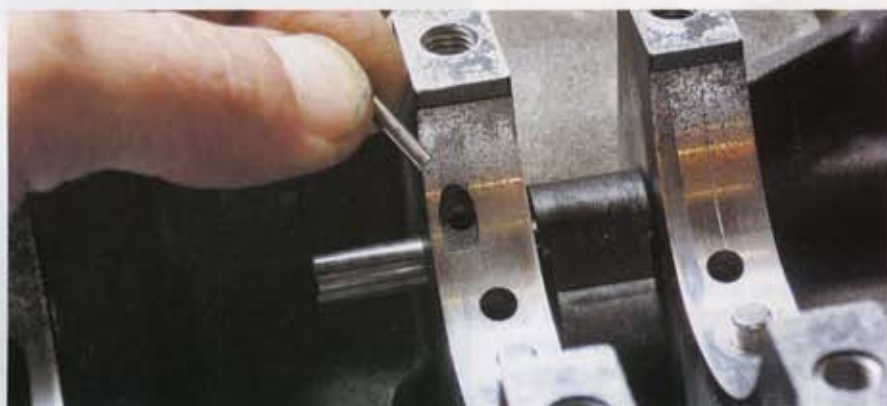
1: There are a few jobs to do before I can rejoin the crankcases. Watch out for this – it's easy to miss. The camchain slipper blade locates into the crankcase with a steel pin, which passes through a drilling close to the centre main bearings. That pin is then secured with this smaller pin, which drops into the bearing housing and is then held captive by the presence of the bearing itself. Forget any of this lot and you'll have to strip it all right down again later.

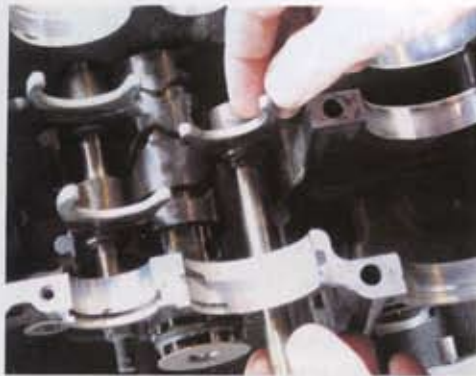
2: The lower crankcase is home to the gear selectors. With the selector drum in place I can offer up the forks to the grooves on the drum, and slide in the two steel pins that locate the forks. I took the precaution of marking the selector forks when I stripped the motor so they could go back in their original positions, but as a rule they will only go in one way. Double check the forks engage with the dogs on the gears when the cases go together, if it all fits it's correct.

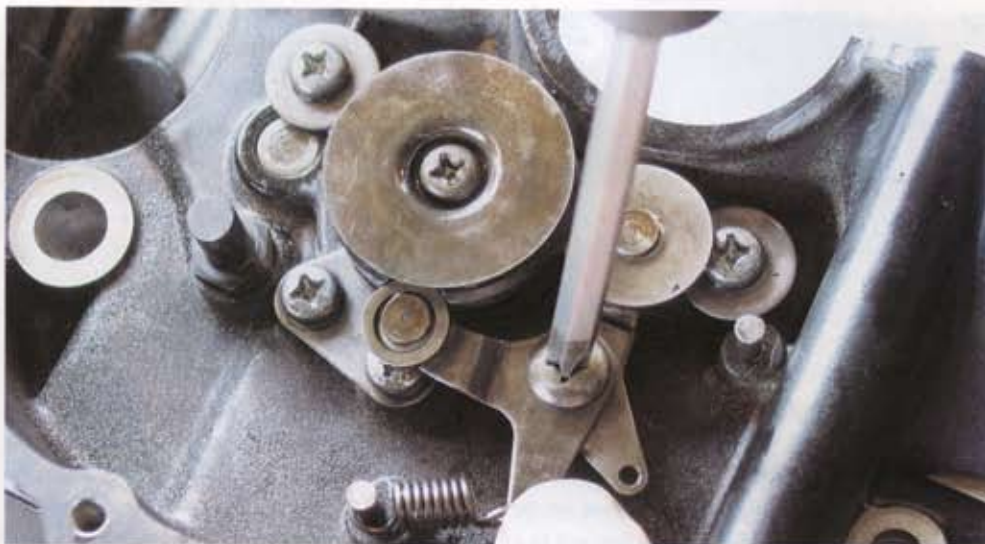
3: The positive stop mechanism for the gear selector comprises these spring-loaded arms, which mount to the back of the clutch housing. Note the two screws with washers, which retain the two selector fork rods, and the catchplate held with two screws, which locates the selector drum. The detent rollers click into place between the pins on the end of the drum.

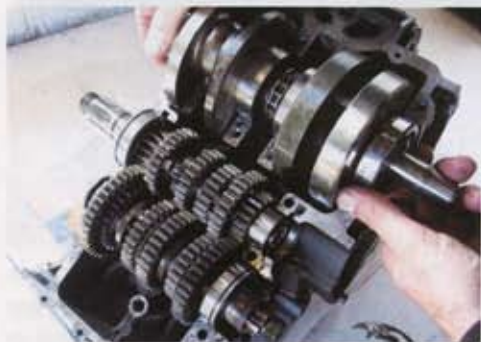
4: I've positioned the two gearbox shafts into the upper crankcase. Watch for any pins and clips that locate the bearings, and this is the time to position the new output shaft seal. With the gears located and rotating freely I've next hooked the new camchain over the crankshaft, and lowered that into place. There are dowel holes in the bearings, make certain they locate correctly onto the pins in the casing. They serve to line up the oil feed holes – miss one out and you'll starve a main bearing of oil.

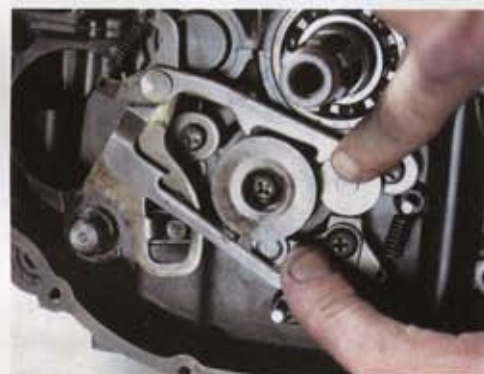
6: The gearshift shaft slides through the crankcase from the clutch side, make sure the new oil seal at the other end is in place first and has a smear of grease inside. These two selector claws now hook over the pins on the end of the selector drum and the shaft pushes home. Note the spring on the shaft which fits around a pin in the crankcase – this is the spring which will return the gear lever to the central position after each gear change.

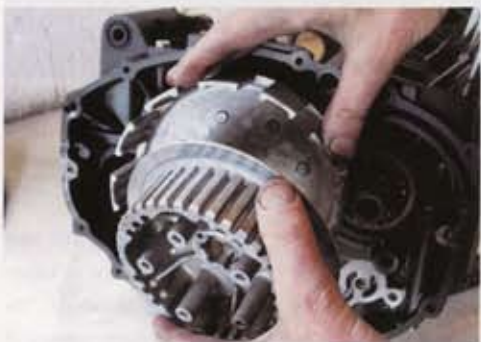
7: Next, the clutch. I've already fitted the primary drive gear to the end of the crankshaft, so now the clutch basket slides onto the end of the input shaft, followed by the inner drum, which engages with the splines on the end of the shaft. A large bearing collar sits in the centre of the basket, and there are thrust washers both behind and outboard of it. Primary drive gears are frequently machined as a set, so I'm using the correct primary drive gear to match the clutch basket, though it's not essential.

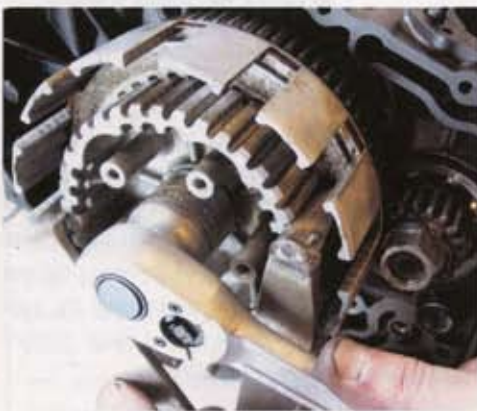
8: Tightening the clutch centre nut can be a problem without some method of preventing the inner drum rotating. I'm using an adjustable clutch holding tool, but if you're really struggling you can wait until the engine is re-fitted in the frame, then engage a gear and hold on the back brake. Make sure you don't forget, as the clutch coming loose in service could be disastrous.

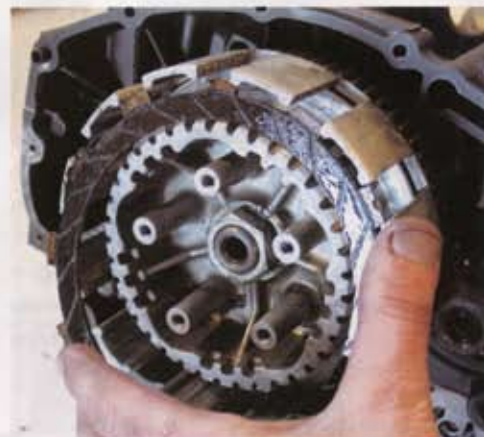
9: With the clutch centre nut tightened up and tabbed down, the clutch plates now go in in sequence, alternating plain and friction plates. Always lubricate the clutch friction plates with fresh engine oil before assembly to prevent the clutch sticking when the engine is started.

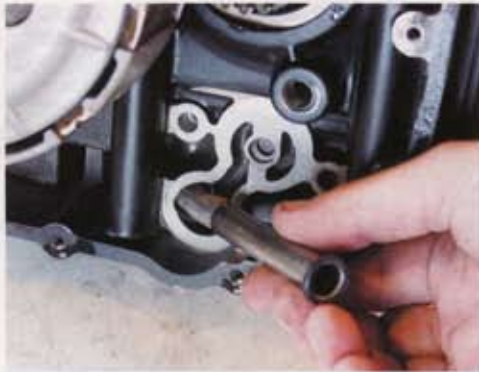
10: Remember the hideously clogged up sump strainer gauze? Here's the new one, and here's where it fits. It slides into the casing behind the oil pump, which is why many owners don't discover it until it's too late. For the couple of quid involved I'd order a new one, and fit it next time you change your oil.

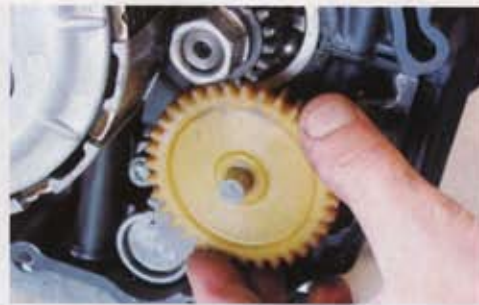
12: The oil pump is driven by this nylon gear, driven by the primary drive gear. It looks a bit flimsy but shows no signs of wear, and I've never heard of one failing. However I've taken the precaution of scrubbing up both the gears in the box of bits, and using the one which looks best. With a bit more slack in the budget I might have been tempted to simply fit a new one for extra peace of mind.

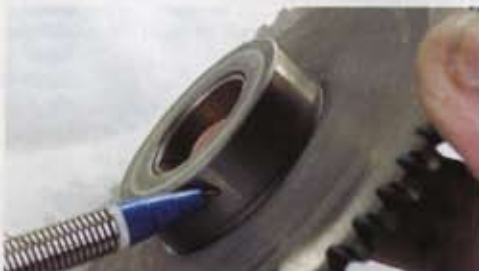
13: Round the other side, now, and before I refit the generator, I'm taking a close look at the components of the starter clutch. This boss is driven by the three starter clutch rollers, and any signs of flattening will result in the clutch failing to engage properly, meaning the starter motor will simply spin freely instead of turning over the engine. As the Z250/305 has no kickstarter, you'll need to replace this if its worn – now is the time to do it.

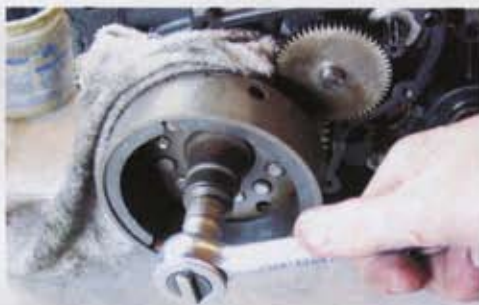
14: I've reassembled the starter clutch to the rear of the generator rotor, which in turn mounts to the taper on the left hand end of the crankshaft. The rotor is then retained with a bolt with a spot of Loctite. To lock the engine I've refitted the starter idler gear and wedged a rag between the gears – a perfectly adequate method provided all traces of the rag are carefully removed afterwards!

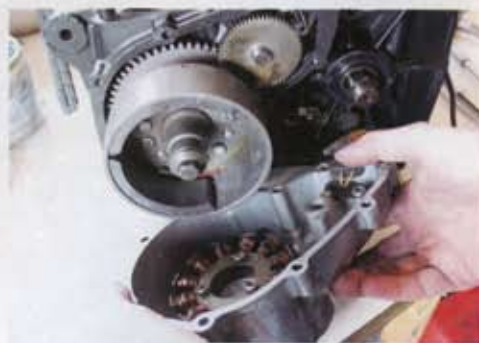
15: The generator stator is captive in the outer cover, and I haven't had to disturb it. However, if you do remove it treat it with great care – the insulation on the windings is easily damaged and must not be bashed or scratched. Two dowels locate the cover to the crankcase, make sure they're both in good nick and correctly positioned.

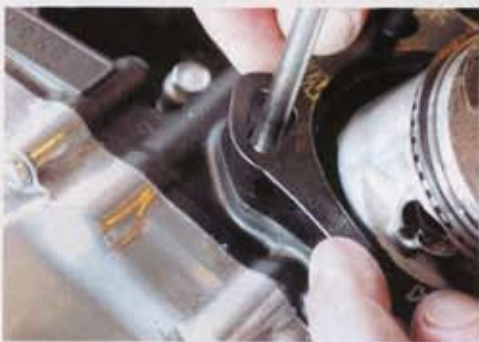
16: Time for top end reassembly. I've fitted the best two out of four pistons to the rods with new circlips, then greased and positioned a new base gasket before I fit the barrels. The pistons should then match their original bores. Watch for the oval holes around the rear cylinder studs; fit the gasket upside down and you could blank off a camshaft oil feed.

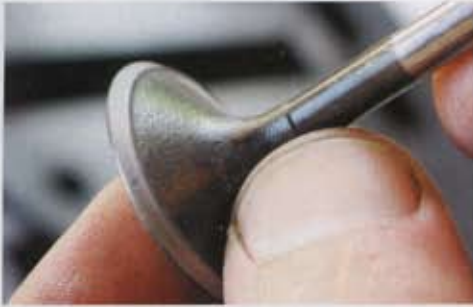
19: After all the disasters, it's quite a relief to discover the valves are in pretty good nick. I've scrubbed each one up on a rotary wire brush to remove the carbon build-up, then lapped them in using a good old fashioned sucker-on-a-stick and some grinding paste to restore the compression seal. This dull, grey ring is how it should look – the seats in the head should look the same.

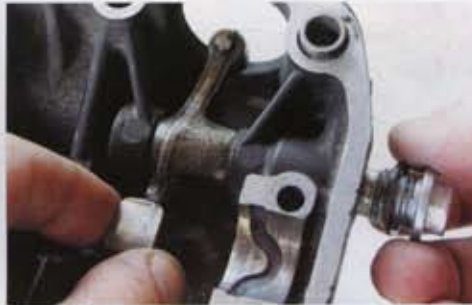
23: I've selected the best four of the rocker arms and can now refit them to the cam cover. My two engines have two different designs of rocker spindle; these screw in, the other type simply slide in and are retained by a rubber plug. Note the copper washers to prevent leaks. I've greased all the cam bearings, lobes and followers to protect the engine when it's first started.

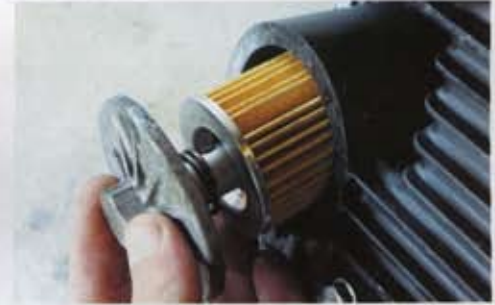
24: I've refitted the points backplate to the head in its original, marked, position and recommend the timing is properly strobed once the engine is running again. To finish off the rebuild, here's a new oil filter going into the lower crankcase half. Note the spring which holds it tight against its housing. And don't heave too hard on the hexagon – it's made of soft alloy and can easily round off or even shear.

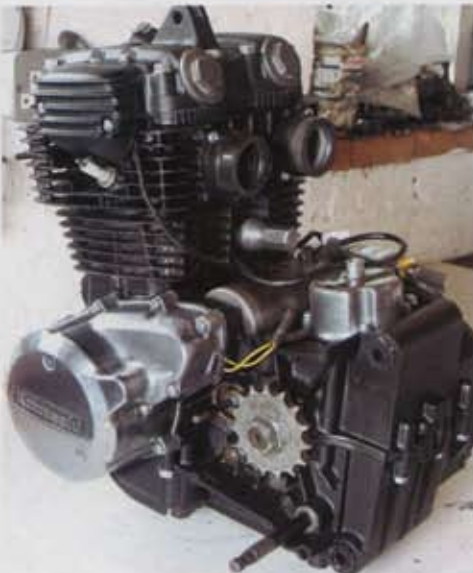
25: Finished and ready to go. It's not as new, but it should be capable of providing reliable motive power for a good few thousand miles. To tidy up the cosmetics, I've sprayed all the major engine castings in VHT satin black. Without shotblasting first it won't look this good forever, but it's an improvement. I've also buffed up the outer covers with a polishing mop on an electric drill, and finished off with a set of budget pattern pan head screws. Mission accomplished.
